Technical Information

Compressor

Compressor failure after AC system repair

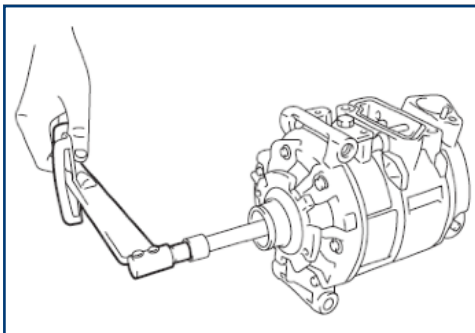
- Higher rotational torque

The rotational torque of a contaminated compressor is higher and it has a “sticky” feeling when rotating the compressor shaft the first time.

Standard value: 2.9 Nm or less.

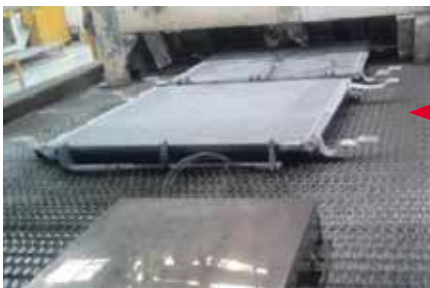
- Production of imitation condenser

The flux is entering the condenser tubes, during the aluminum brazing process of the non OE condenser.

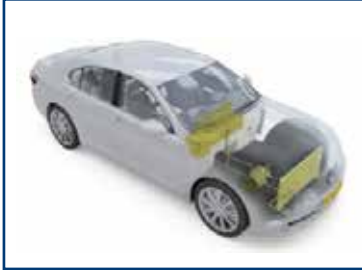
After installing the non OE condenser, with flux inside...

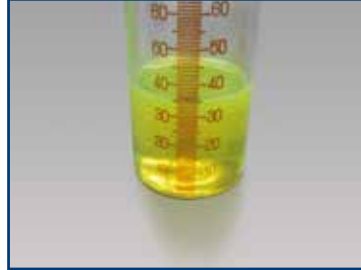
...and adding UV-Dye to the AC system...

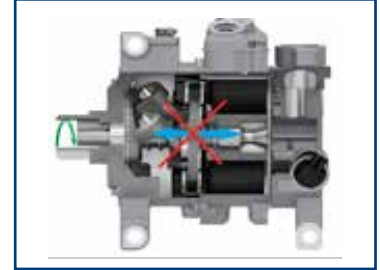
...after cooling down period, the compressor still rotates, but does not regulate anymore.

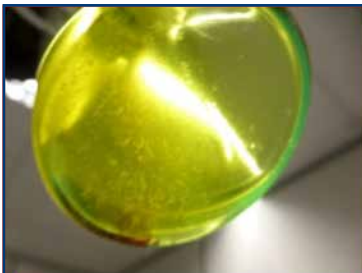
PAG oil is turned into a jelly like, sticky oil.

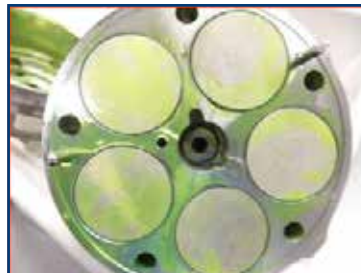
Pistons are bonded in the cylinders at minimum displacement.

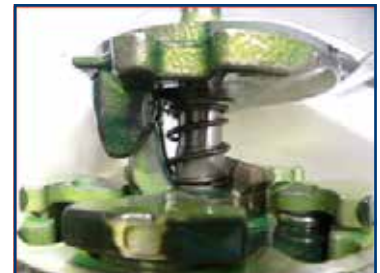
Not possible to remove pistons with force.

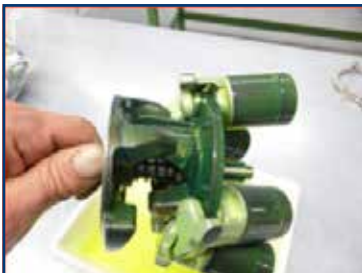
Pistons can only be removed with an alcohol based solvent.

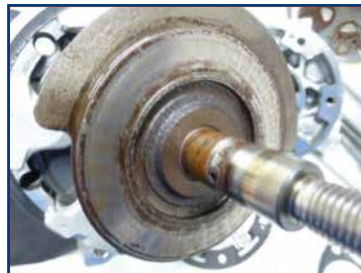
Heavy corrosion after only one day.
